Technical Service Bulletin

GT40 Service Bulletin: 0601GT Engine Run On Key Off

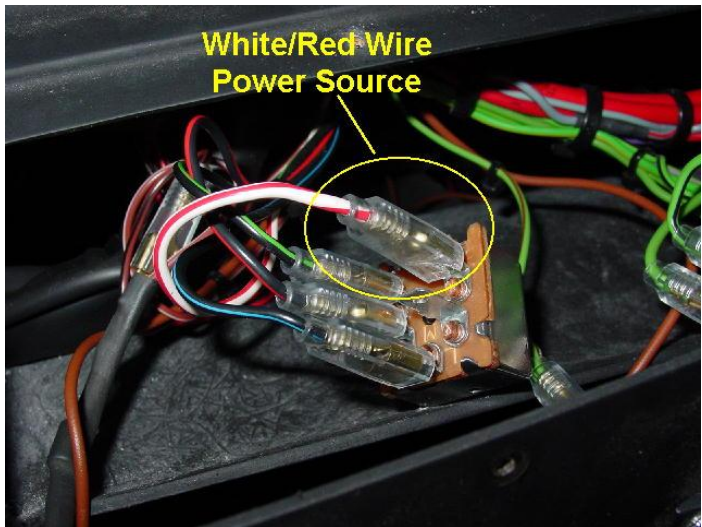
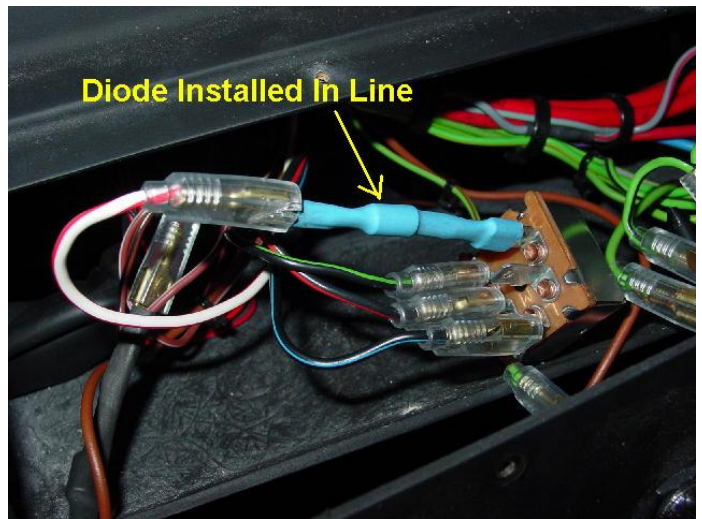
Switch does not need to be removed. It is here for clarity

9. Remove the White/ Red wire and install the diode in line as shown above.
