## GT40 Service Bulletin: 0702GTB HVAC Blower Fan Relay Retrofit

This bulletin will show how to install the Superformace GT40 Blower Fan Relay Retrofit. This added harness has been designed to eliminate a high amp draw on the blower switch. This is being done to eliminate concerns of future switch failure problems.

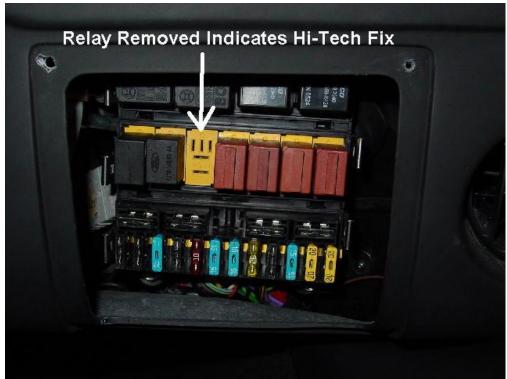
**Note:** Make sure your HVAC blower system has not had the run-on repair using a diode installed as in bulletin 0601GTB. If you have this, it must be reversed and the Hi-Tech fixed implemented. You can tell this by examining the Fuse/Relay block. If the relay shown below is removed the Hi-Tech fix is used. If this is not the case and information is needed on the Hi-Tech fix please call 513-738-4000 ext 2.

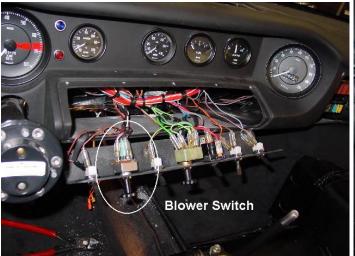
Fig. 1 Fig.2

- 2. Remove the center console riser under the center of the dash. Remove the ignition switch if it is located in this area.
- 3. Remove the screws holding the main switch panel in the center of the dash. (Fig.1)
- 4. If your ignition switch is on the left side of the dash, remove the switch panel below it. (Fig.2) If your ignition switch is in the center below the dash it is not necessary to remove this panel.

12.Locate the blower switch on the long panel. Figure 1 shows the location.

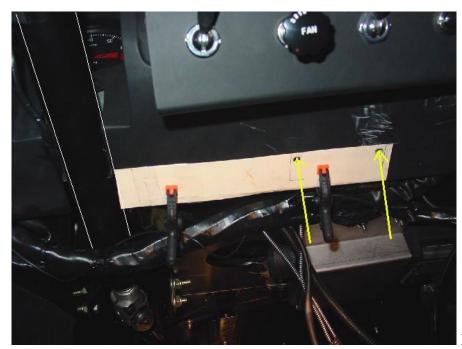
Fig.3

5. Use the template, figure 4 from the next page. Lay this under the dash with the long side toward the end at the steering column. Line it up along the edge of the dash and mark the holes. See fig. 3 Drill two 7/64" holes being careful not to damage any of the wires.

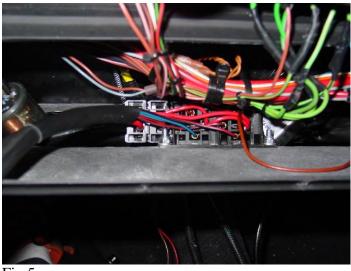
Fig.5 Fig.6

- 6. Install the fuse and relay panel using two 5 mm bolts, washers and nuts. The relays and fuse should protrude from the rear of the dash slightly and the back of the panel will face out the opening as in figure 5.
- 7. If your ignition switch is on the left side of the panel, run the double red wire from the fuse panel over the steering column to the switch opening on the left side of the dash. (Fig.6)
- 8. If your ignition switch is under the dash in the center, run it under to this location as in figure 7.

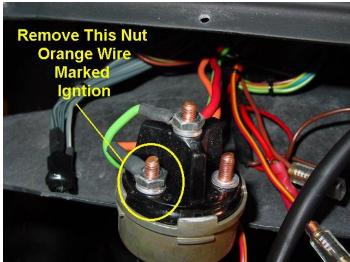
Fig.7 Fig.8

- 9. Remove the ignition switch if not already done. Find the terminal containing the orange wire that is marker IGN. (Fig.8)
- 10. Attach the double red wire to this post. (Fig.9)
- 11. Find the Brown wire from the panel and attach it to the steel chassis using a self-taping screw. The steel chassi is immediately ahead of the dash when viewed from underneath. Be sure to clean the paint off so there is a good ground connection. (Fig. 10)

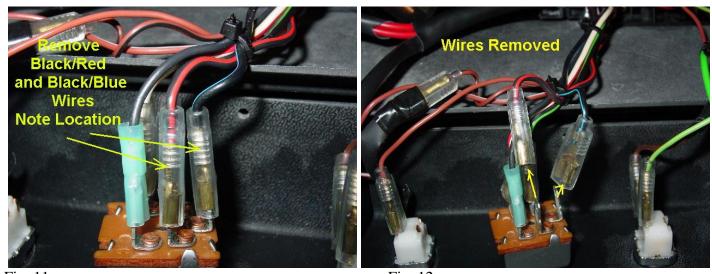
Fig. 11-12

13.Remove the Black/Blue wire and the Black/Red wire. Note their location on the switch.

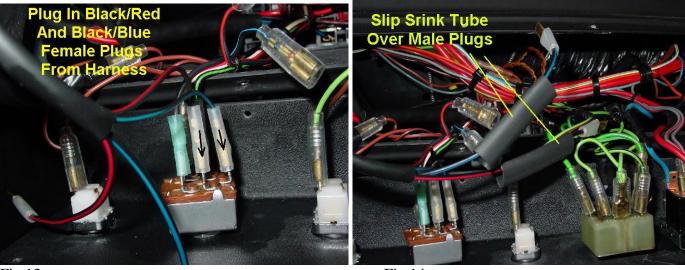
Fig.13 Fig.14

- 14.Plug the female Black/Blue wire and the Black/Red from the panel harness into the switch matching the colors to the same location as the removed wires. (Fig.13)
- 15. Slide the 3/8" shrink tube over the remaining two male plugs from the panel harness. (Fig. 14)

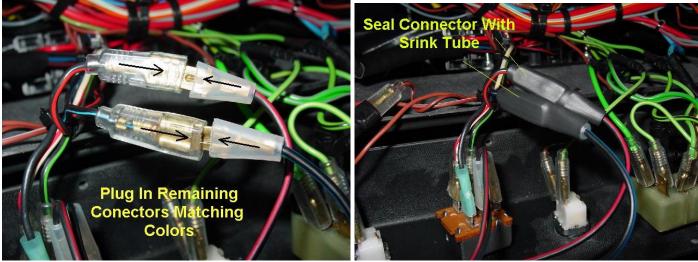
Fig. 15 Fig.16

- 16.Plug the remaining harness male wires into the two female plugs removed from the switch. Make sure they fit together tightly, if not squeeze the female plug with pliers to tighten.
- 17. Pull the shrink tube over the plugs and seal them together by heating as in figure 16.

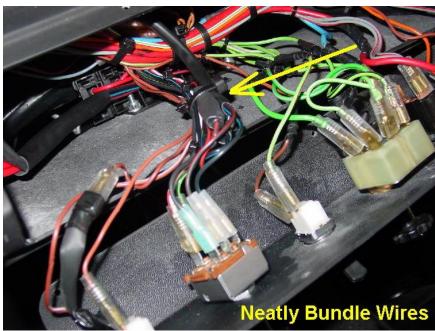
Fig. 17

- 18. Neatly zip-tie the wires tighter as shown in figure 17.
- 19. Reinstall all panels and reconnect the battery. Test the blower fan for proper functions.

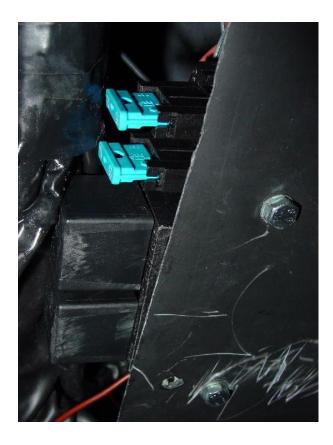
The fuses and relay will be accessible from under the dash as shown above.
