Graziano transaxle

Chevrolet oil pan material removal and bolt swap.

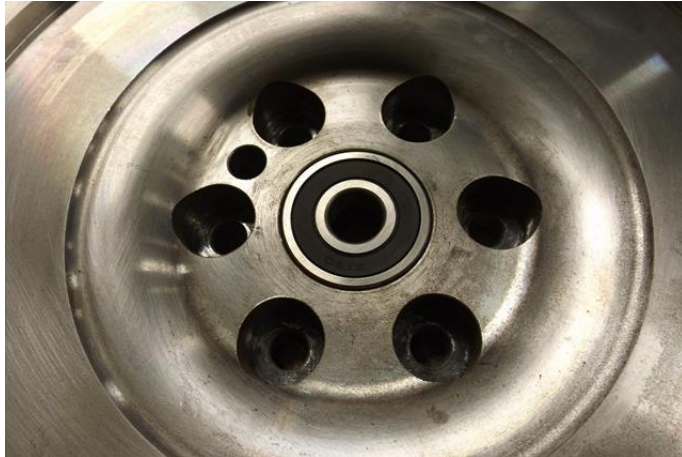
Note indent on ring gear and clutch pressure late during installation

Flywheel installed

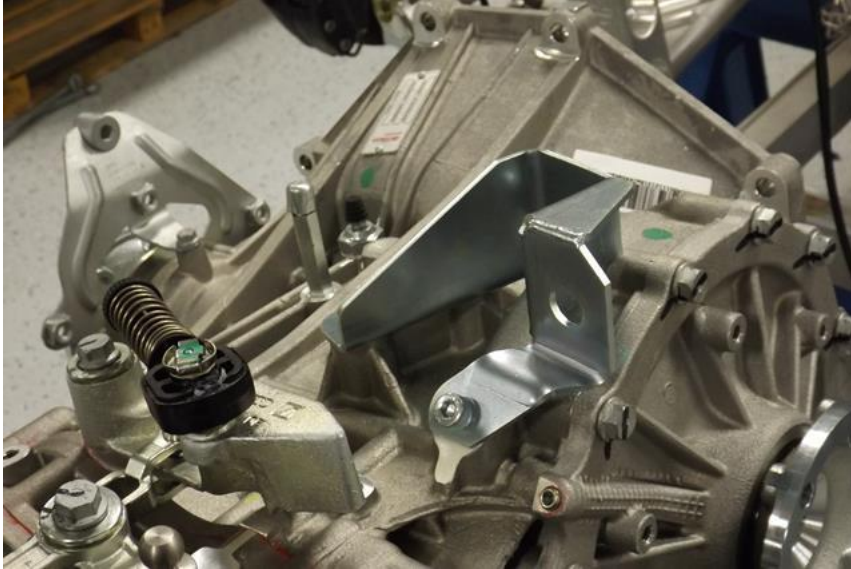
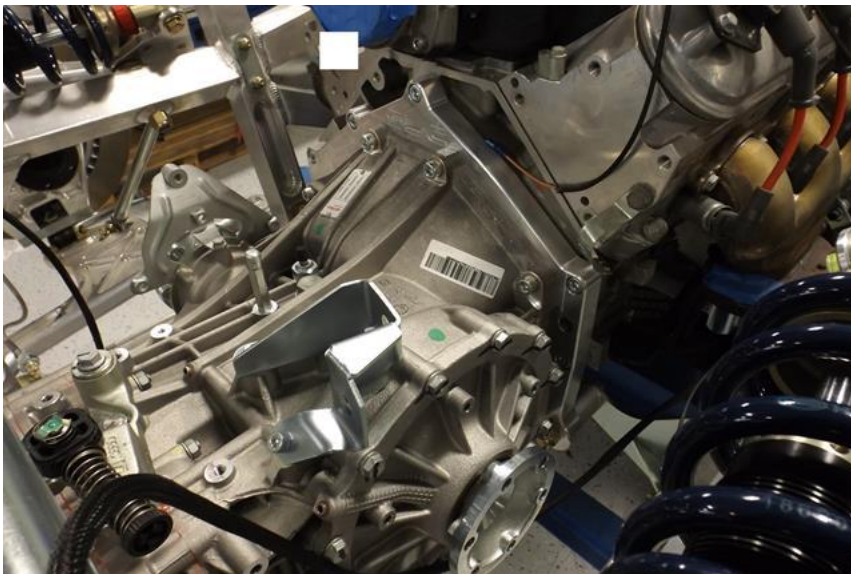
Cable shift bracket installed ontop of transaxle

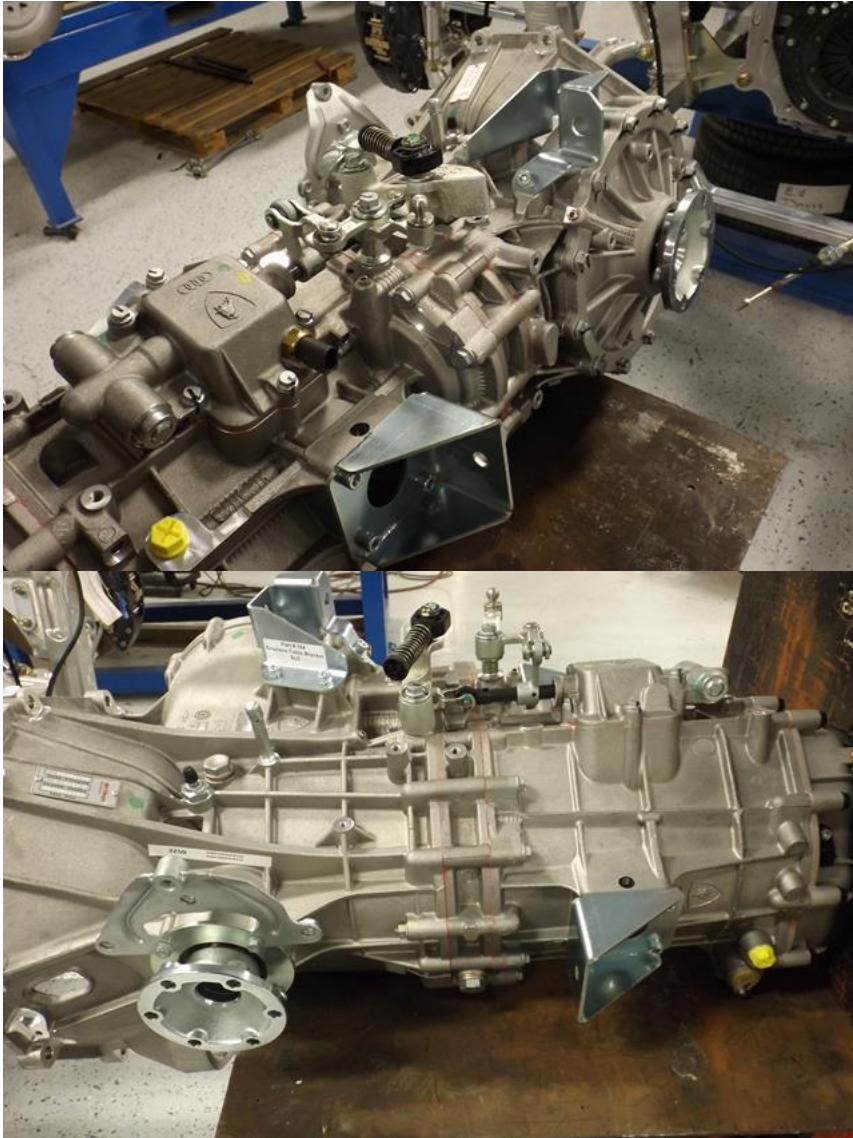
Side mount brackets installed with hole facing forward

Yellow plug shows location of clutch line location on inderside of the transaxle... install a 12mm x 1.5 to -3an 90 degree male fitting
