LAKEWOOD BELLHOUSING ALIGNMENT PROCEDURE

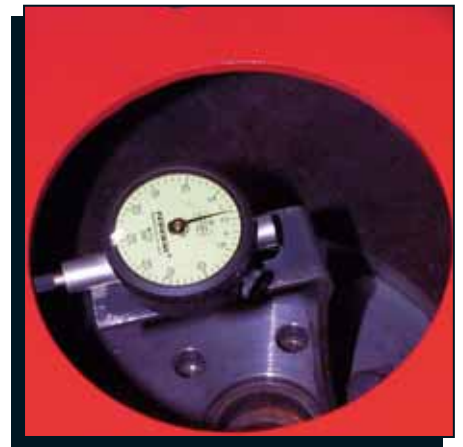
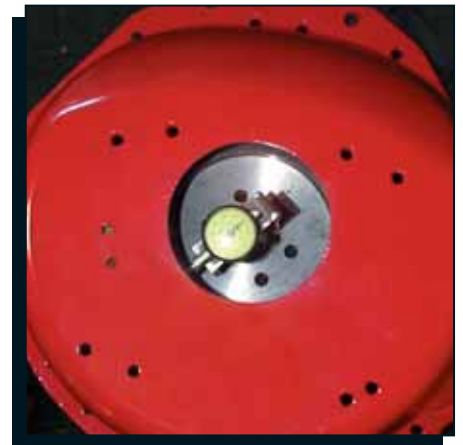
1. Remove clutch assembly from flywheel and install bellhousing on engine block. (It is easier when you leave the clutch assembly off the flywheel.)
2. Install dial indicator base on the flywheel and adjust plunger to contact the register bore of the housing. (See photo.)

3. Rotate the flywheel and note indicator reading. Misalignment is one-half of the indicator reading (maximum allowable is .005").
4. To correct off-center condition, select the offset dowel pin pair that is closest to one-half of the indicator reading. (i.e., if reading is .016", $1/2R=.008"$ use .007" dowels. If reading is .024", $1/2R=.012"$ use .014" dowels).

8. Install and tighten bellhousing securely. Remount the dial indicator and recheck the register bore runout (Repeat step 3).
9. To make small corrections or adjustments to the alignment, you will need to remove the bellhousing and drive the offset dowels out of the block. Reposition the dowels using the slot as a reference point and re-install. Re-check register bore run-out. Repeat this procedure until the register bore is within limits.
